# Public Archives and other Sources for Surveying of Dumpsites and Polluting Enterprises before 1950

**Anne-Sofie Fleischer Michaelsen**, *Department of Environmental, Social and Spatial Change, Roskilde University, Denmark*  
E-mail: [asmichaelsen@gmail.com](mailto:asmichaelsen@gmail.com)

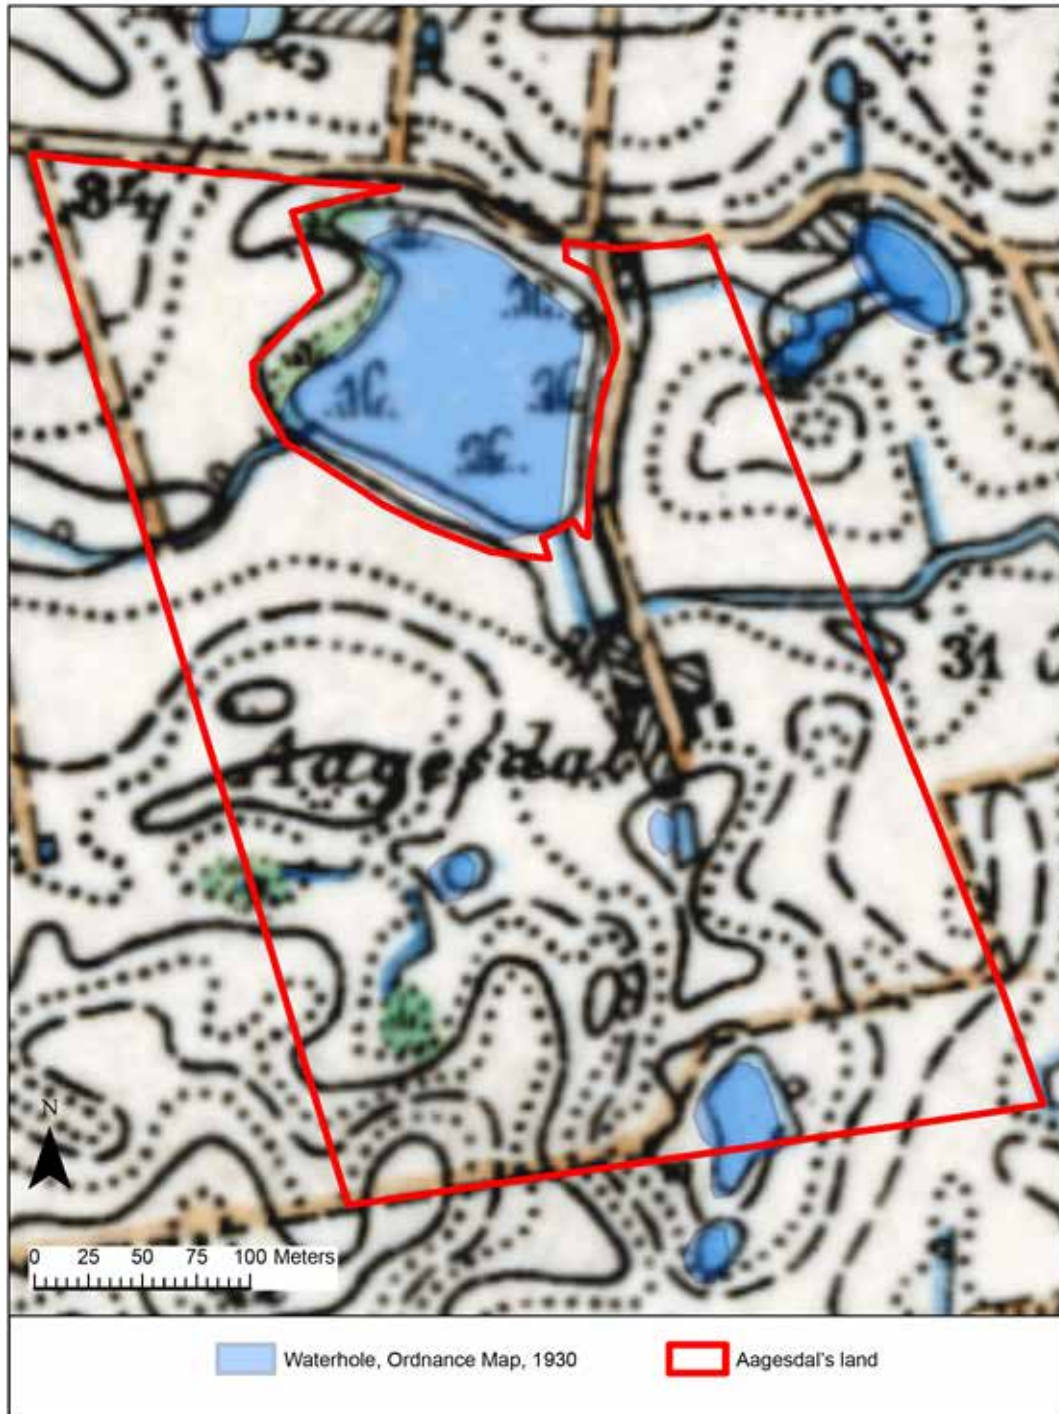
**Figure 2.** Comparison of waterholes around the former Aagesdal farm in the topographical map on the scale of 1:20.000 (Ordnance map) based on field survey in 1899-1900 and the topographical map on the scale of 1:20.000 (Ordnance map) corrected in 1930, from the Danish Geodata Agency's nationwide digital map series.

It was also observed that waterholes in Aagesdal's land are not at the same geographical location on the two maps. Waterholes on the map from 1899-1900

are located east-northeast of the same waterholes on the map from 1930 (Michaelsen 2012). The direction is the same as for the contour lines, but the distance is not the same, it is less - approximately 8 meters. See Figure 2.

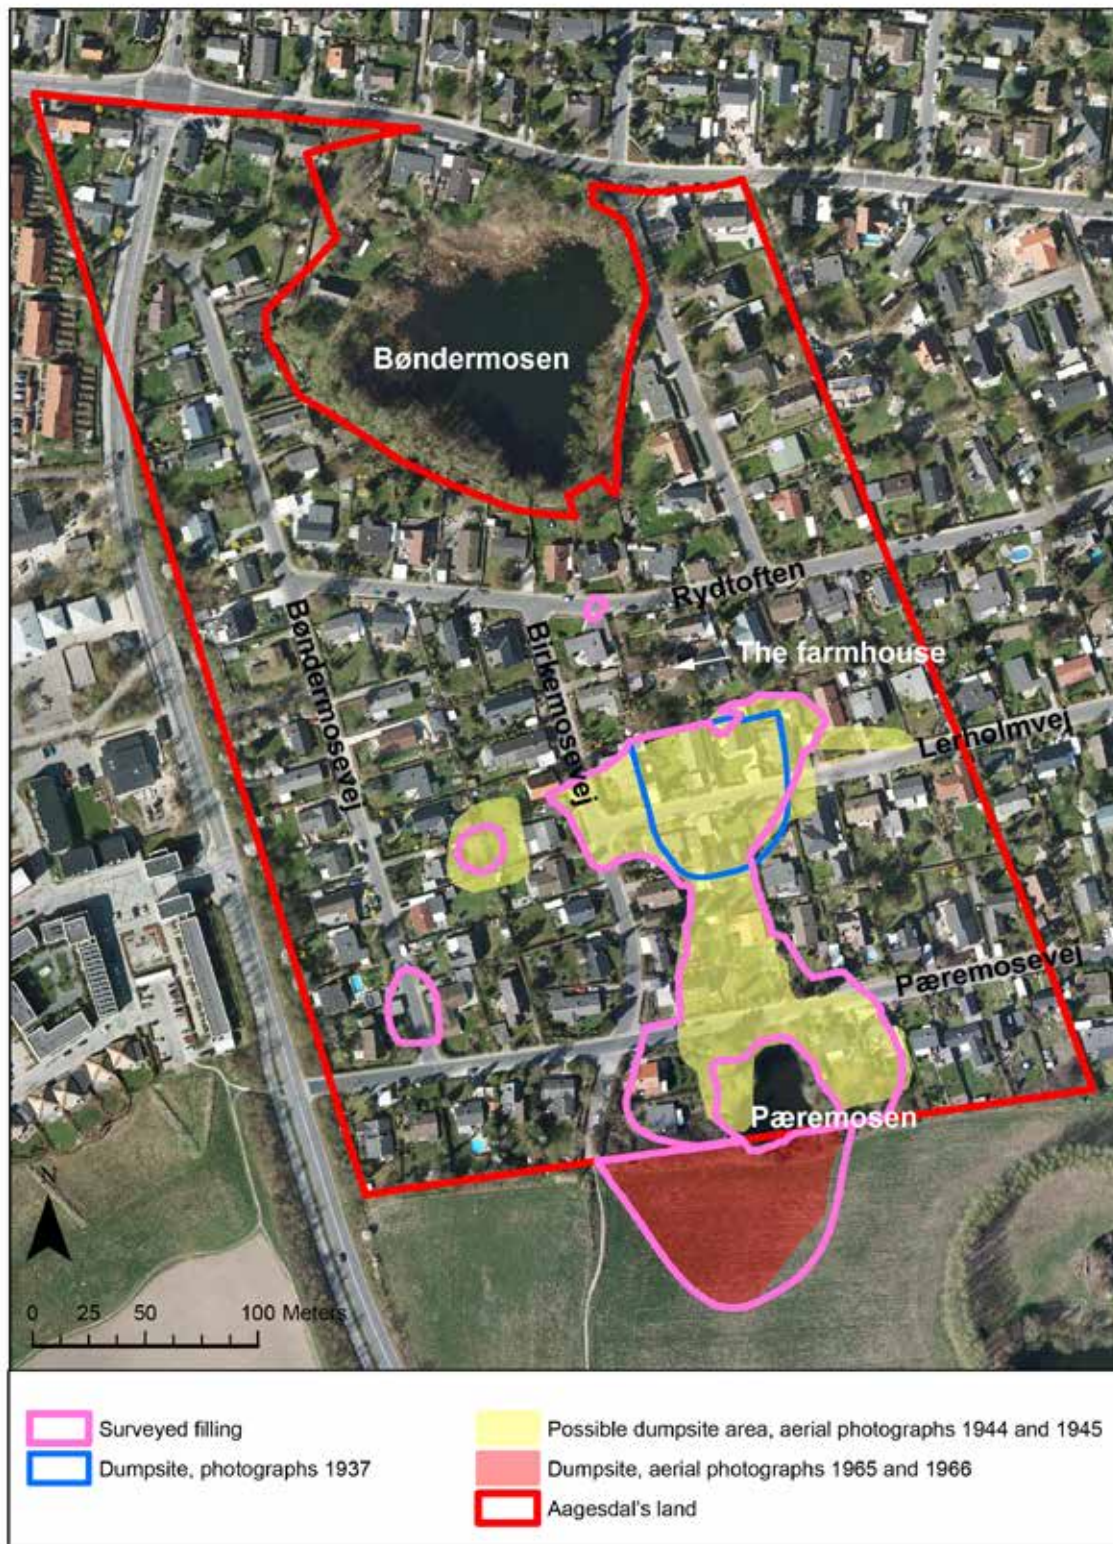
*Figure 3.* A section of orthophotograph DDOby 2009 with the single-family houses on Aagesdal's former land and the recreational green area south of the former farm land together with the areas where filling was surveyed by comparison of terrain heights in DK-DEM/Terrain and the Fortification Map in the selected areas and where the historical sources indicates a possibility of dumpsite waste.

On Aagesdals land, the biggest fill thickness occurs in a former low area in terrain with a little waterhole, which lay immediately south of the buildings on Aagesdal, before filling with household waste started. Here, the fill thickness can be up to 2.5 meters above the former ground surface around the waterhole. To this must be added the fill in the waterhole. This thickness cannot be estimated by the comparison due to lack of information on the waterhole's depth. In the comparison, it was not possible to distinguish between dumpsite waste or soil and other kinds of fill from the later use on the former farm land. This made it not possible to delimit the geographical extent and the vertical extent of the dumpsite waste today. The total amount of fill in the area where the dumpsite can be seen on photographs taken in 1937 and is estimated to be approximately 8000 m<sup>3</sup>. A production of landfill gas would be possible from the household waste in the waterhole.

Just south of the farm land in the area of the dumpsite, the biggest fill thickness occurs in the filled part of the two waterholes called Pæremosen. Here, the fill thickness is a minimum 1.3-2.0 meters above the former ground surface around the waterholes. The total amount of fill in the dumpsite area is estimated to be approximately 11000 m<sup>3</sup>. In the fill in the waterholes, a production of landfill gas would be possible depending on the organic matter in the fill.
